Manhole Inspection Summary

Manhole # S41UU_015MH

Location Address: **1437 CARSWELL ST**

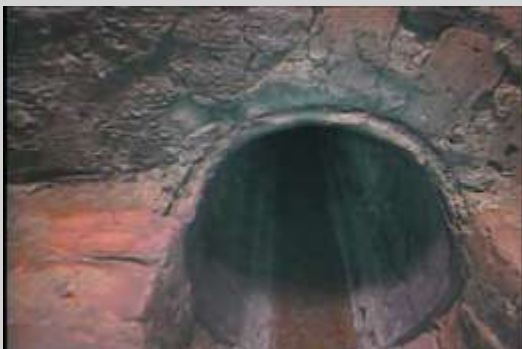
Pipe In @ 5 O'Clock

8 in. Circular Gravity Sewer

Pipe Material: **Clay** ☐ Pipe Lined

Infiltration: **None** Pipe Seal Cond: **Unknown**
